**Flood Control Project Maintenance
Levee Inspections**

Fall 2018 Levee Maintenance Deficiency Summary Report

Sacramento River Basin

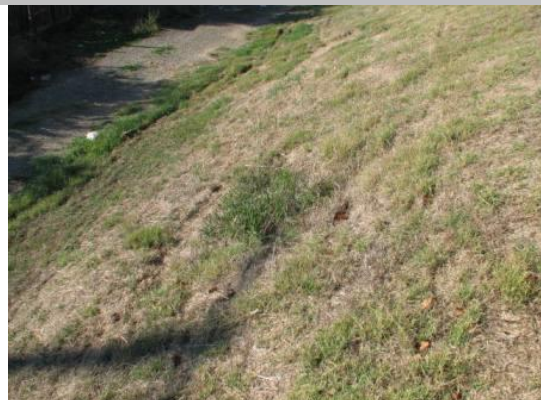
Photo 2 of 2 : FA_2018_NA0001_51_164_20180911_00051.jpg

Another view of the depression on the landside levee slope.

11/17/2011 Hole/depression approximately mid-slope.

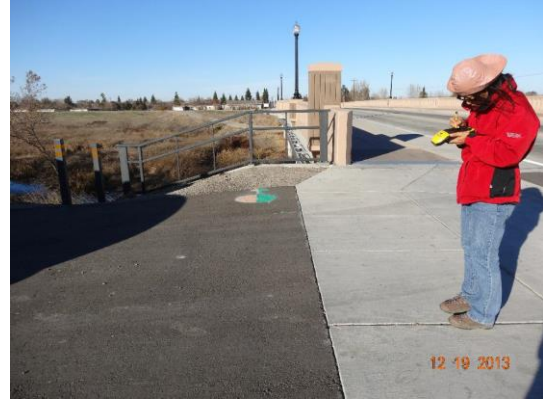
Photo 1 of 1 : UCIP_FA_2018_31169_57044.jpg

LM Start	0.66	Rating **	M	Issue No.	184
LM End	0.66	Issue Type +	En	Location *	
Category	Supplemental			GPS Latitude/Longitude	
				Start	End
Item	DWR UCIP Field Study			38.623668 °	38.623668 °
				-121.457156 °	-121.457156 °
DWR ID	24800				
Comment Code					
Inspector Comment					
FS_ID:31169 DS_ID:24800 EP_NO: N/A Repair Type: Non-Urgent Crossing Status: Found UCIP Comments: Need to coordinate with the City of Sacramento to determine if structure (assumed indicated by green/orange symbol) crosses levee or symbol is referencing bridge. FIELD_STRUCT_DESC: Indicator of crossing found on waterward side edge. Symbol for Flood Control Structure (green/orange circle) was found during field inspection 12/19/13, symbol matches flood control structures that the City of Sacramento inspects. FS Date: 12/19/2013

Indicator of crossing found on waterward side edge. Symbol is a Flood Control Structure (green/orange circle).

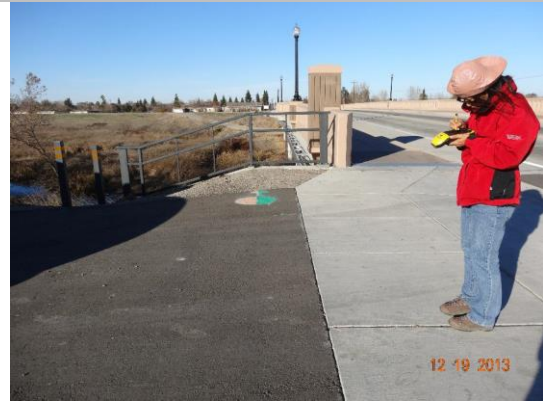
Photo 2 of 3 : UCIP_FA_2018_53488_57041.jpg

Comment Code						
Inspector Comment						
FS_ID:53488 DS_ID:24266 EP_NO: 18641-1 Repair Type: Non-Urgent Crossing Status: Found UCIP Comments: 07/18/2018 Crossing appears to be the same as last time. Markers have not been placed. PG&E provided supporting documentation that this crossing is in good shape. Plus it is getting raised to the 200-year water surface elevation. PG&E records for this distribution main indicate that there were no leaks found on the 06/2017 leak survey and the pipeline is operating correctly according to the 12/2016 CP inspection. Crossing is downgraded to "Non-Urgent" until the gas line is raised to the 200-year level. (A. McDonald - DWR UCIP)8/11/2016 Markers still missing. LMA representatives, Tim Kerr and Richard Marck, provided permit for 4-inch PG&E gasline to be raised to 200-year water surface elevation. Pipe will be modified on both the right and left bank. Elevation through the levee will need to be modified once pipe is raised through levee. (DWR UCIP - omagana)12/19/2013 no markers visible on waterward or landward side indicating this is a gas line--need to contact owner to determine if this crossing is gas line. (DWR UCIP - omagana) FIELD_STRUCT_DESC: 4-inch coated steel natural gas pipeline through the levee, 1.5 feet below the crown. Corrugated metal (CM) cutoff wall around the pipeline at the center of the levee. Pipeline is hung along the downstream (DS) side of the bridge across the channel. Pipeline is protected by a cage along the side of the bridge. 4-inch gate valve will be installed on the landside (LS) approximately 355 feet from levee crown (near Fairbanks Avenue and Norwood Avenue). In case of an emergency related to this pipeline, PG&E has identified the following contacts: PG&E's local pipeline engineer, Mike Aronoff at 916-307-9472 (cell), and Gas Control (north) at 800-442-4743. For non-emergency issues, please contact the local PG&E Gas Pipeline Operations and Maintenance (GPOM) supervisors for the Sacramento region, David Wade at 209-639-1039 (cell), or Ron Hicks at 916-396-9038 (cell). (4-inch pipe installed under Permit No. 3417, 1961 - Pacific Gas and Electric Company [PG&E]; 4-inch pipe removed and replaced under Permit 18641, 2011 - PG&E; 4-inch pipe through levee (both right and left bank) raised above the 200-year water surface elevation under Permit No. 18641-1, 2016 - PG&E). [Additional Reference(s): DWR Levee Log, 2002]. FS Date: 7/18/2018

Paint on paved levee indicates crossing could be a storm drain.

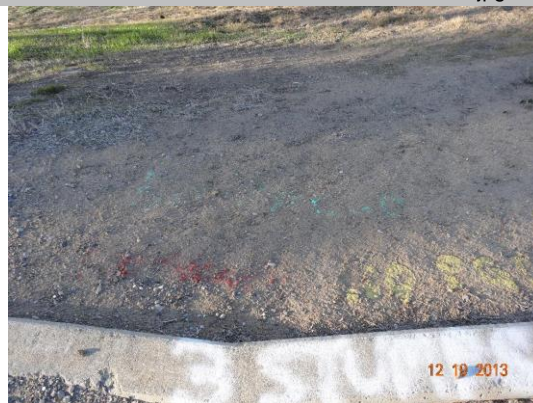
Photo 2 of 3 : UCIP_FA_2018_29732_54975.jpg

Underground service alert (USA) paint markers visible on waterward shoulder--unable to confirm type of crossings.

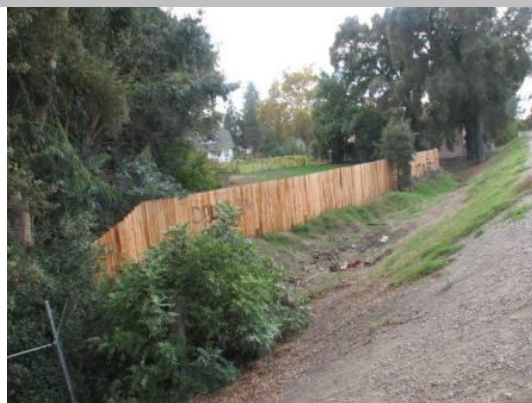
Photo 1 of 1 : FA_2018_NA0001_51_176_20180911_00055.jpg

11/17/2011 Wooden privacy fence built within 15' of the levee toe.

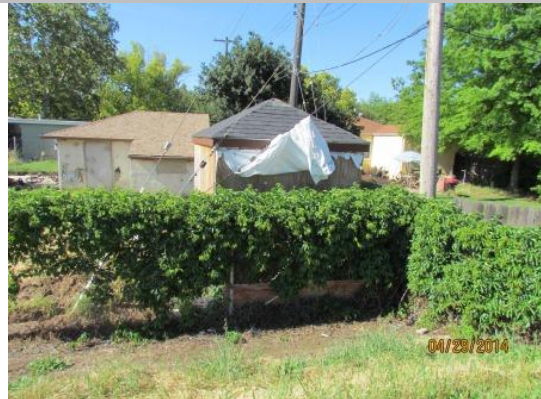
Photo 1 of 1 : FA_2018_NA0001_51_30_20180911_00024.jpg

Building on concrete pad within 15 feet of the landside levee toe.

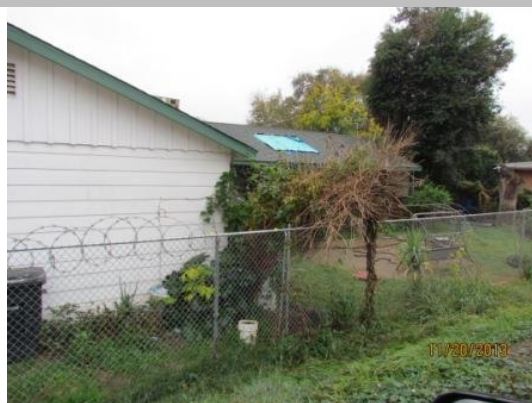
Photo 1 of 1 : FA_2018_NA0001_51_1_20180911_00001.jpg

View of the fence and landscaping at the landside levee toe.

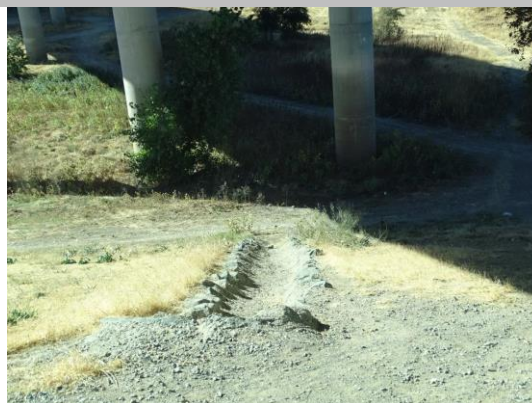
Photo 1 of 1 : FA_2018_NA0001_52_42_20181015_00058.jpg

View of footpath dug into levee slope and lined with rocks. Fall 2018

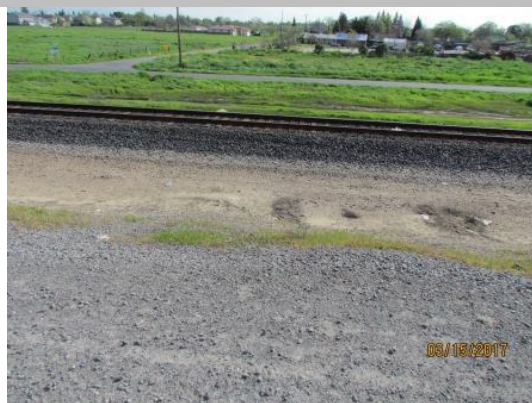
Photo 1 of 2 : FA_2018_NA0001_52_150_20180911_00010.jpg

Spring 2017 - View of the depression, the issue has not gotten any worse since the fall 2011 inspection.

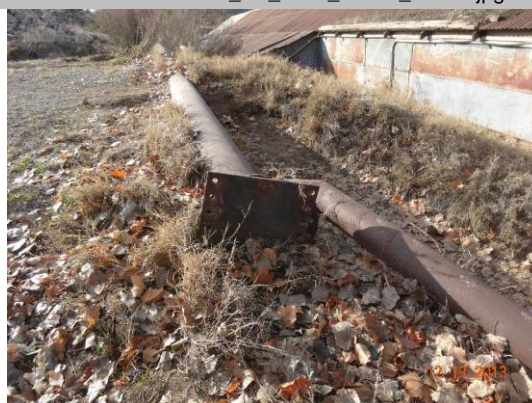
Photo 1 of 2 : UCIP_FA_2018_29944_55267.jpg

Remnants of old crossing located on levee crown.

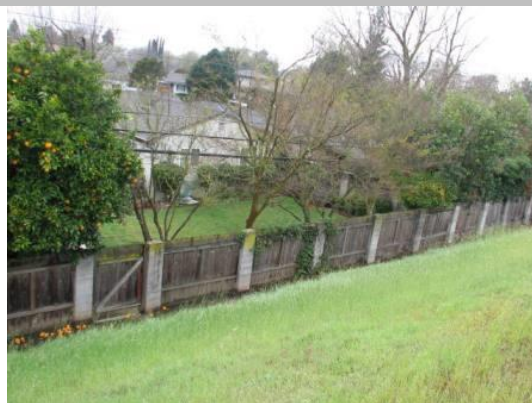
Photo 1 of 1 : FA_2018_NA0001_55_17_20180911_00017.jpg

03/16/2012 Wood privacy fence completely obstructs access and visibility.

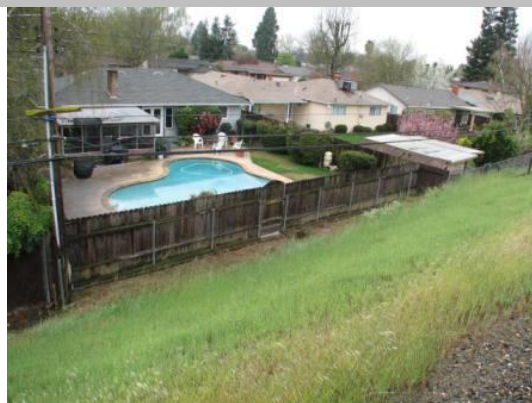
Photo 1 of 1 : FA_2018_NA0001_55_190_20180911_00162.jpg

03/16/2012 Wood privacy fence completely obstructs access and visibility.

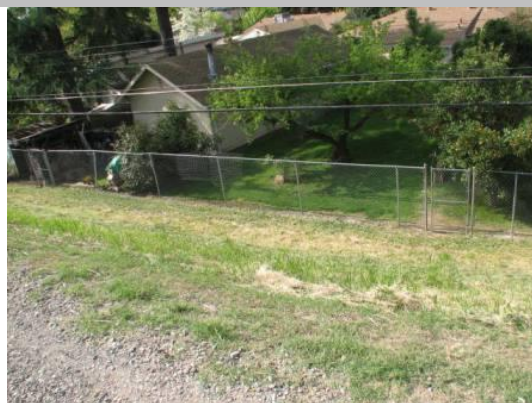
Photo 1 of 1 : FA_2018_NA0001_55_194_20180911_00165.jpg

04/14/2011 Planter boxes have been removed. Chainlink fence partially blocks access.

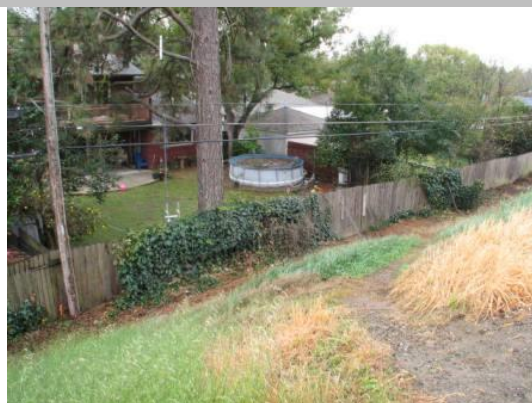
Photo 2 of 2 : FA_2018_NA0001_55_199_20180911_00170.jpg

03/16/2012 Wood privacy fence completely obstructs access and visibility.

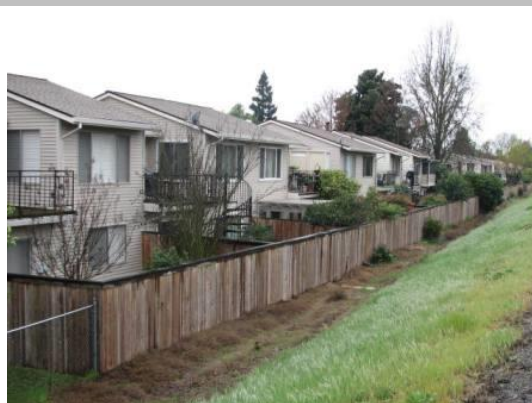
Photo 1 of 1 : FA_2018_NA0001_55_77_20180911_00064.jpg

03/16/2012 Wood privacy fence completely obstructs access and visibility.

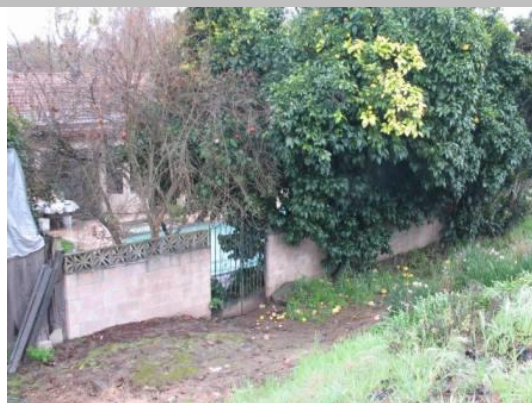
Photo 1 of 1 : FA_2018_NA0001_55_92_20180911_00078.jpg

03/16/2012 Cinder block fence completely obstructs access and visibility.

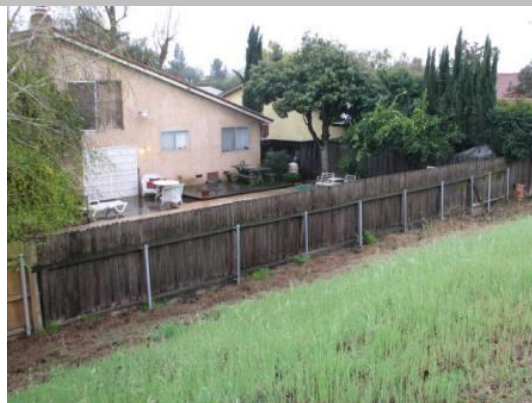
Photo 1 of 1 : FA_2018_NA0001_55_94_20180911_00080.jpg

03/16/2012 Wood privacy fence completely obstructs access and visibility.

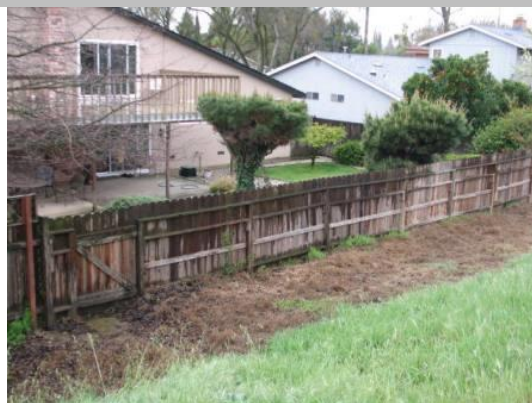
Photo 1 of 1 : FA_2018_NA0001_55_97_20180911_00083.jpg

03/16/2012 Wood privacy fence completely obstructs access and visibility.

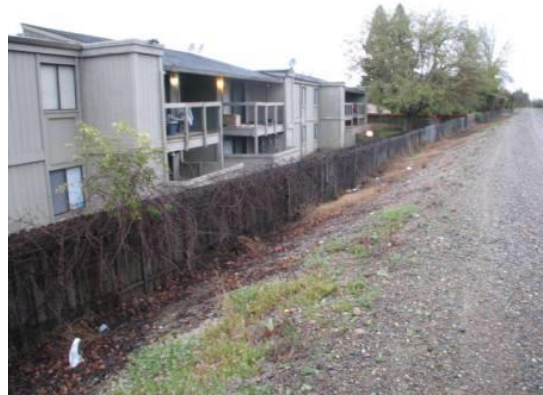
Photo 1 of 1 : FA_2018_NA0001_55_168_20180911_00148.jpg

03/16/2012 Wood privacy fence completely obstructs access and visibility.

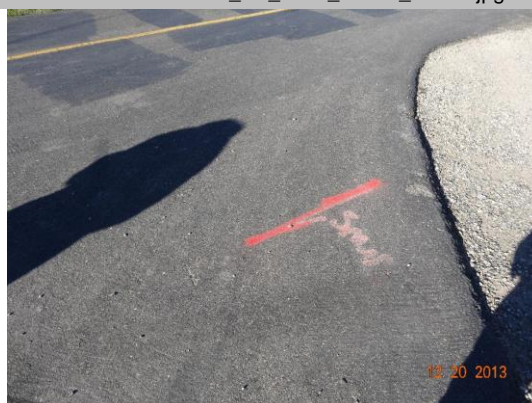
Photo 1 of 3 : UCIP_FA_2018_40803_48512.jpg

Underground Service Alert (USA) marking present on pavement however, unable to verify crossings.

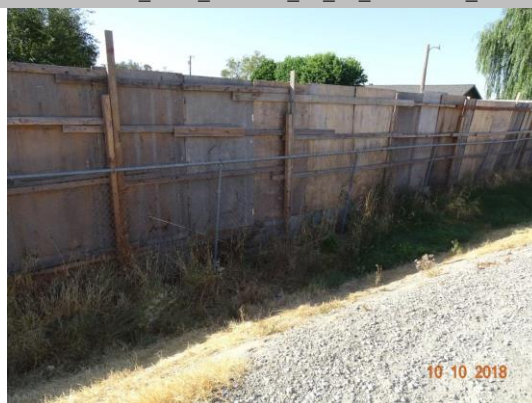
Photo 1 of 1 : FA_2018_NA0001_59_13_20181011_00017.jpg

View of raised wooden fence that blocks visibility along levee easement. Fall 2018

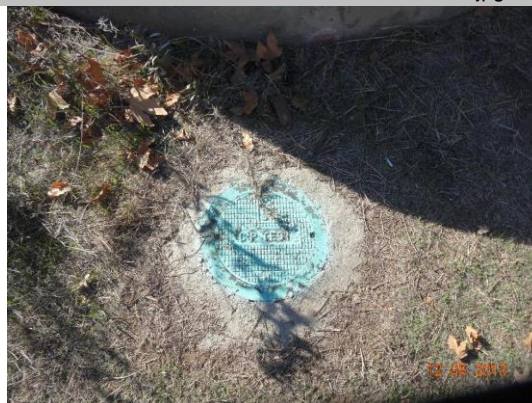
Photo 3 of 3 : UCIP_FA_2018_30124_55520.jpg

Small handhole found need concrete cylinder.

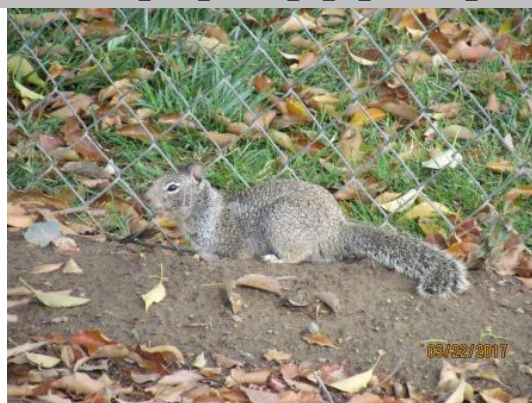
Photo 2 of 2 : FA_2018_NA0001_60_27_20180911_00009.jpg

View of the rodent at the levee toe causing levee damage.

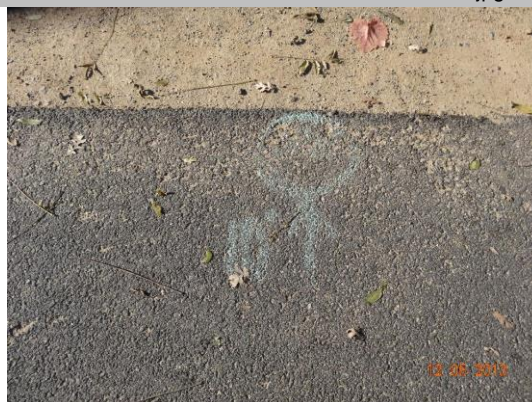
Photo 3 of 3 : UCIP_FA_2018_29633_54789.jpg

Faded paint markings located on levee crown.

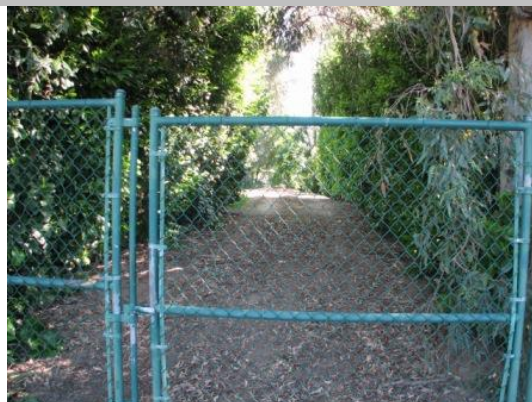
Photo 1 of 1 : FA_2018_NA0001_61_16_20180911_00003.jpg

Levee encroached on by property owners north of Arden Way. This section is not reasonably accessible.

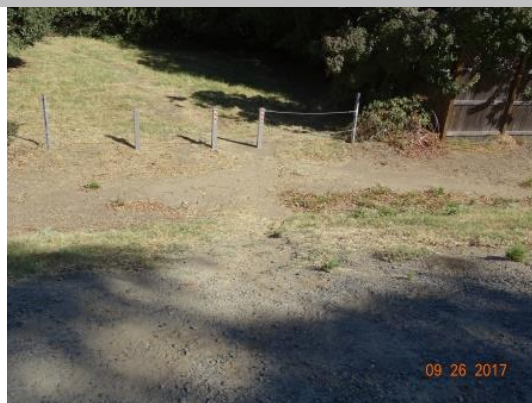
Photo 1 of 1 : FA_2018_NA0001_61_2_20180911_00001.jpg

View of the footpath on the levee slope.

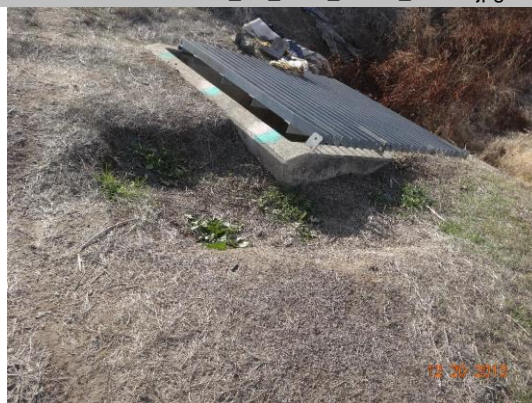
Photo 3 of 3 : UCIP_FA_2018_31313_57351.jpg

Concrete headwall located on waterward side--depression found on wall edge.
